DEMONSTRATION AND VALIDATION OF TECHNOLOGIES TO MITIGATE CORROSION ON INFRASTRUCTURE COMPONENTS AT FORT BRAGG: INITIAL RESULTS

Robert Mason, Larry Gintert, Michael Miller, Kevin Klug, PhD, and Mark
Singleton, PhD

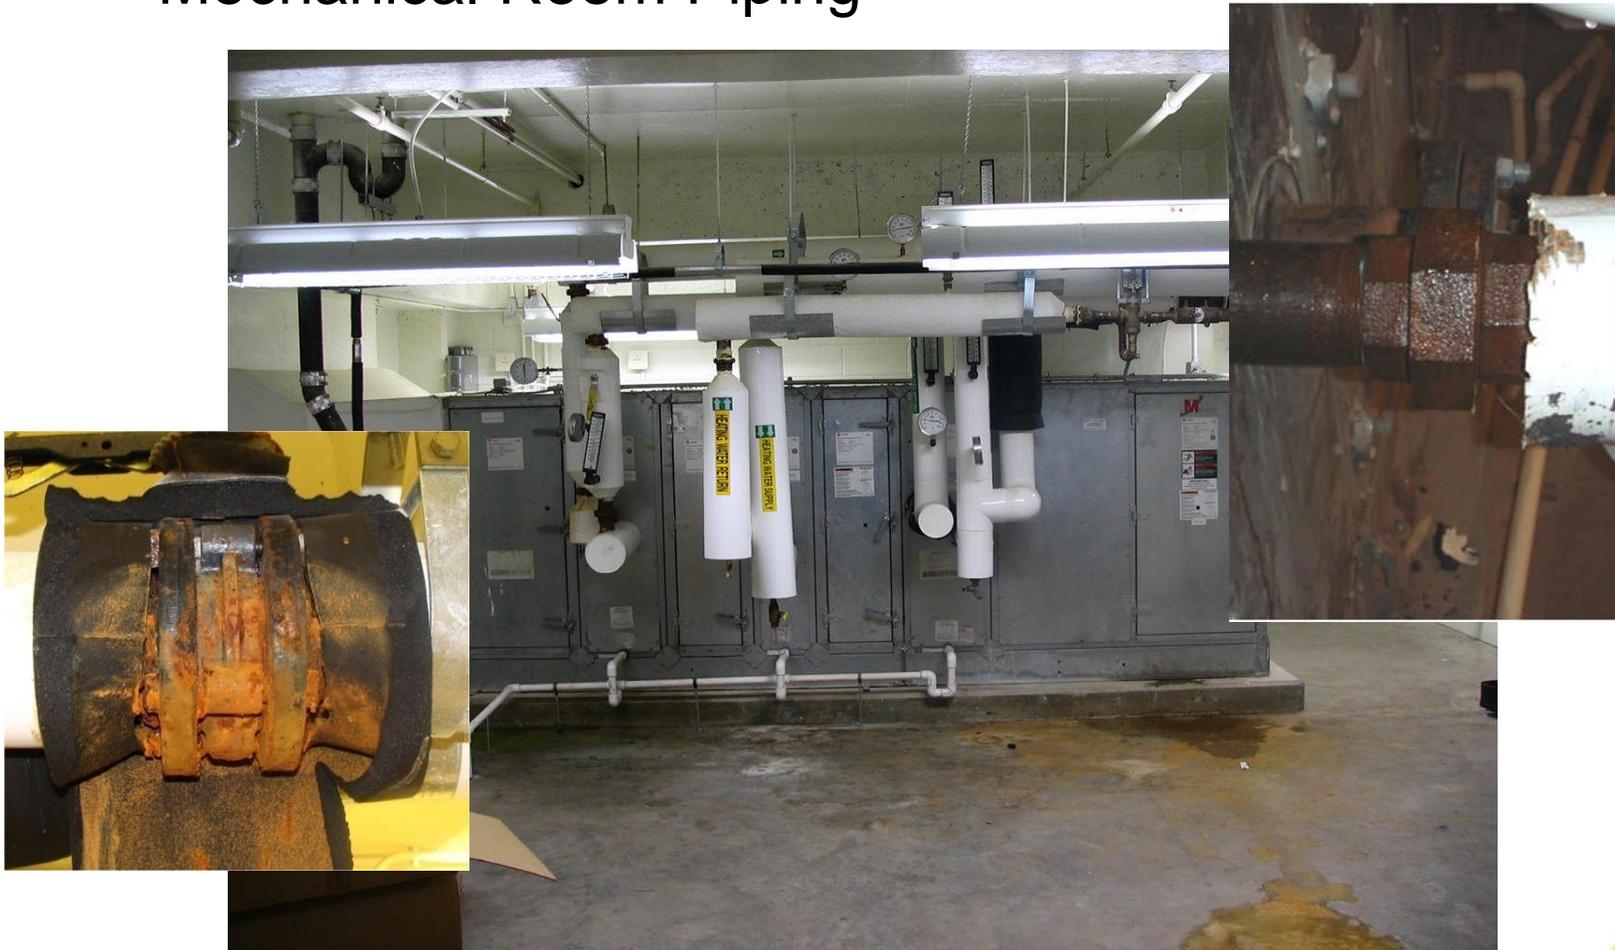
Mechanical Room at Fort Bragg, with corroded piping union joints

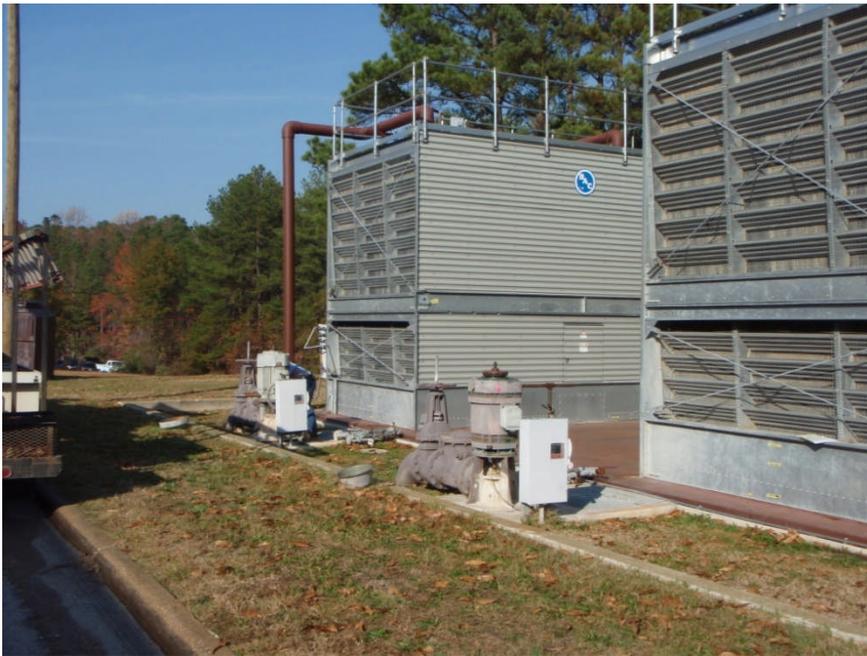
Cooling towers, Central Cooling Plant, Fort Bragg

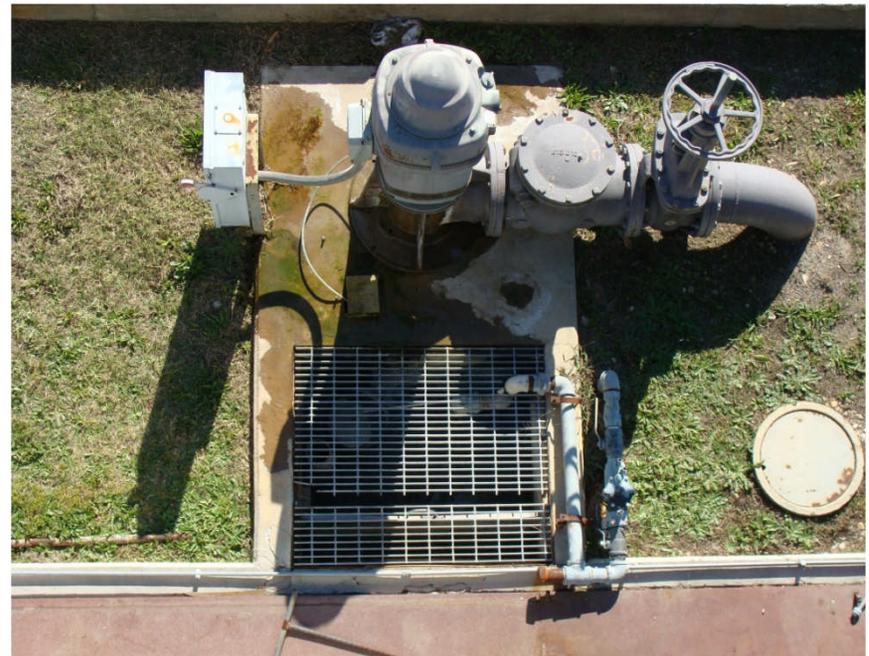
Overhead view of pump sump

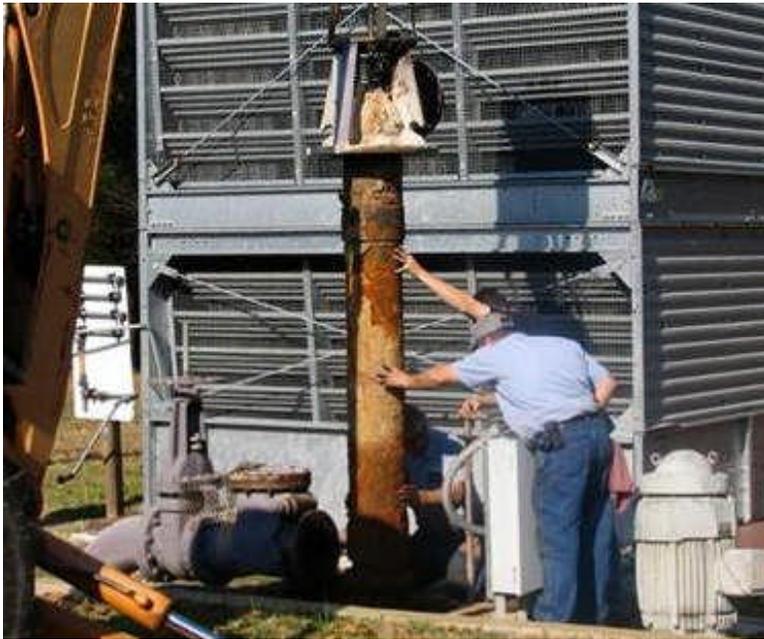
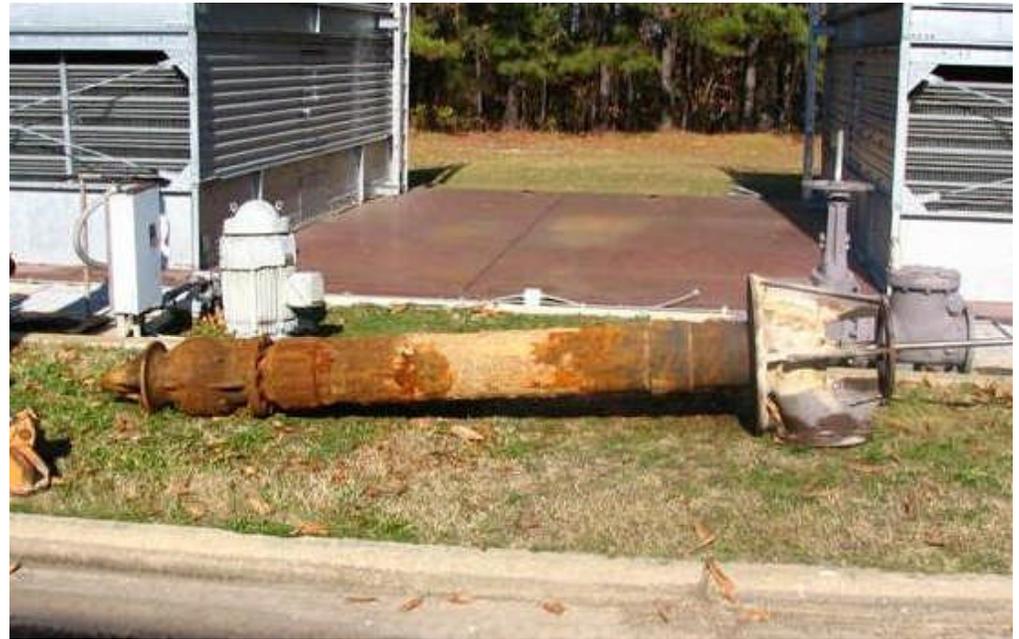
Removed pump, showing severe corrosion on shaft (near water surface)

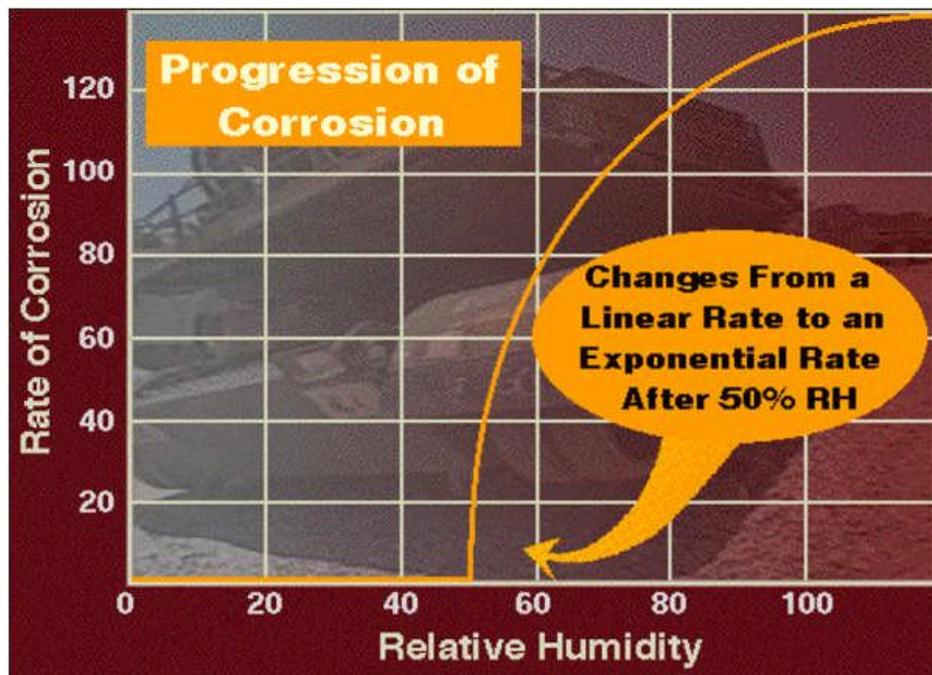
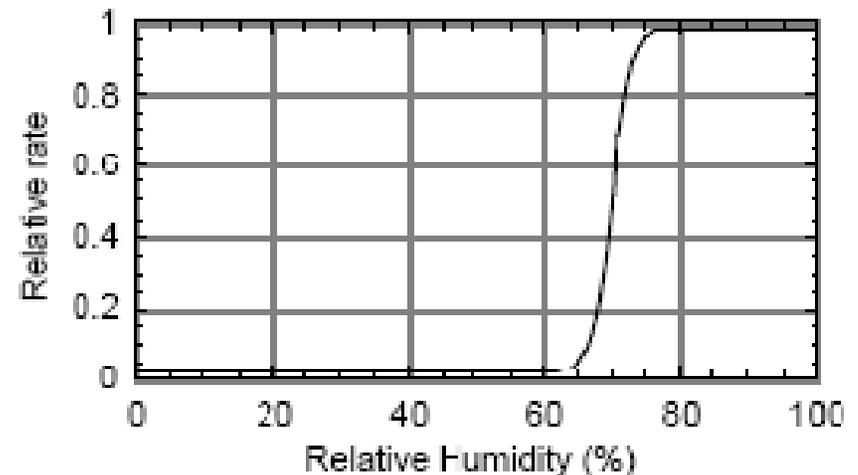
SOURCE: Rob Sorensen and Jeff Braithwaite, "Statistical Modeling of Corrosion Induced Electronic Failures," Presentation for 1997 Life Cycles Workshop, Sandia National Labs, November 4, 1997

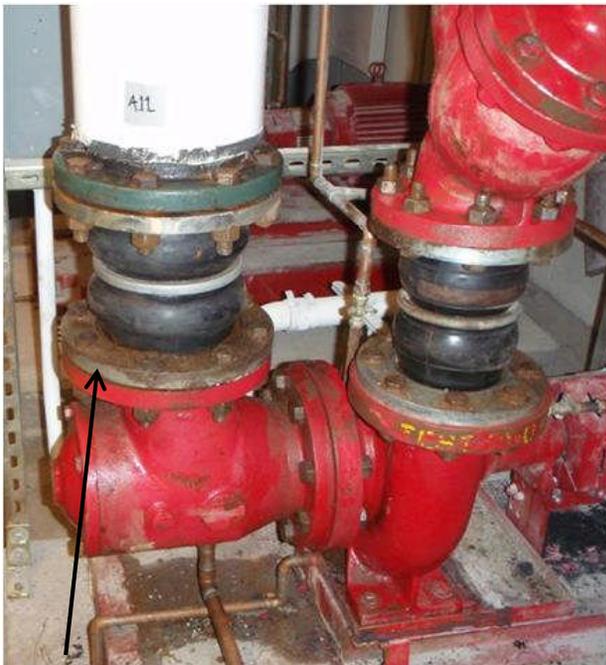
Pre-installation, chill water pump:
rust evident even on stainless
steel flanges

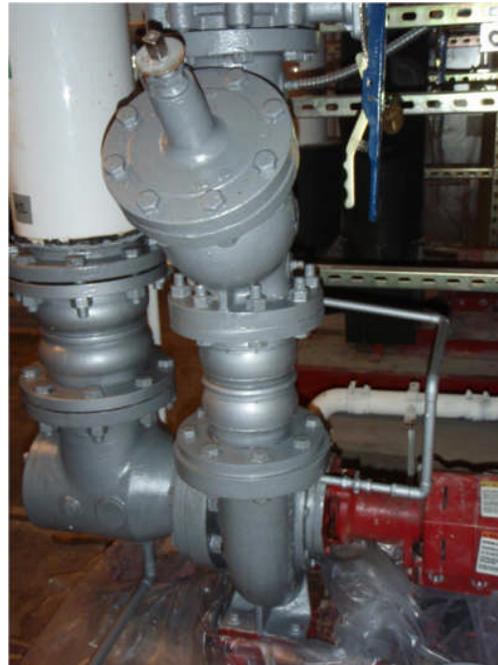
Primer: aluminum-loaded
polyurethane

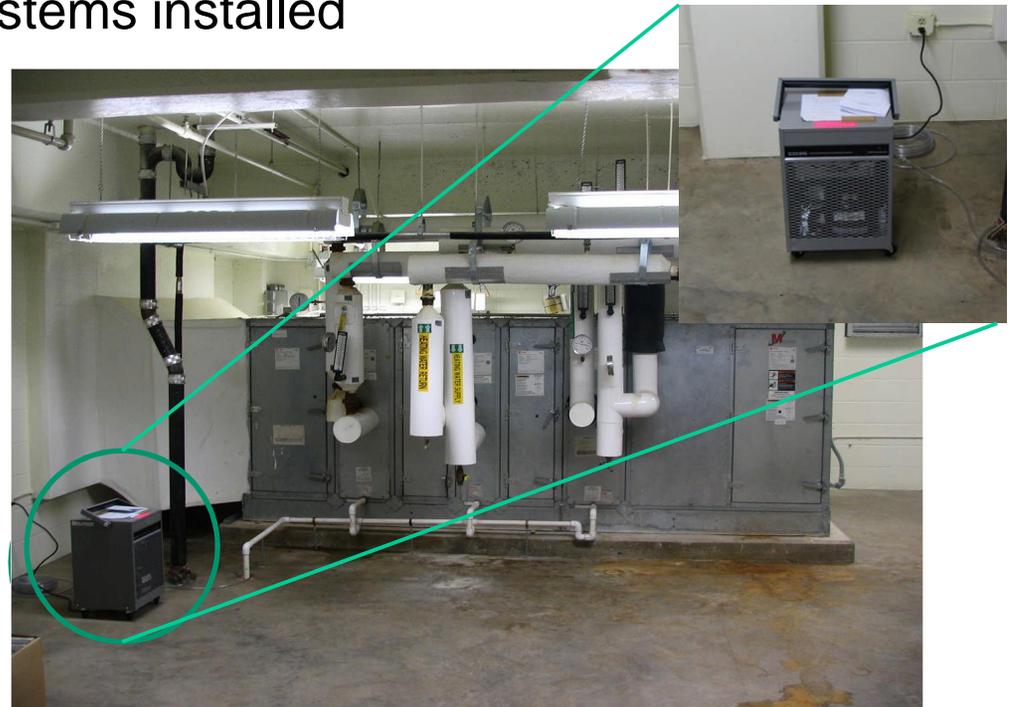
Dehumidification used in another mechanical room

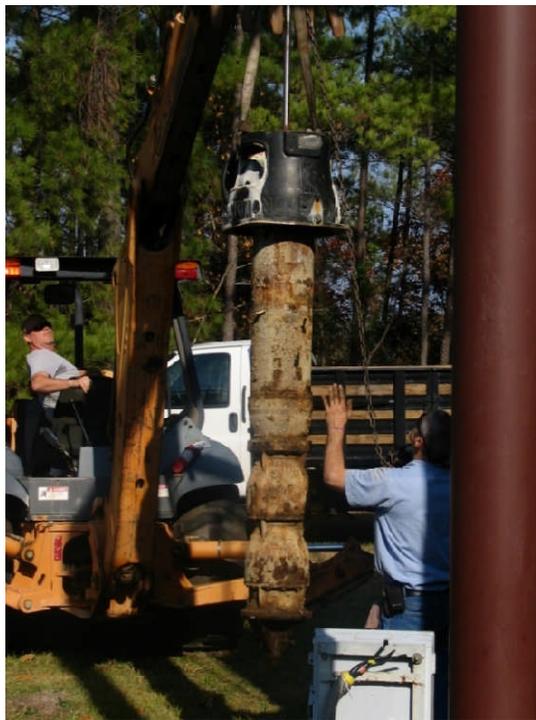
- Cooling Tower Pumps
 - Pumps removed
 - Sandblasted to remove corrosion

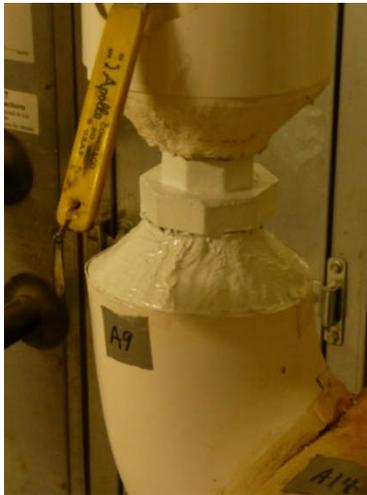
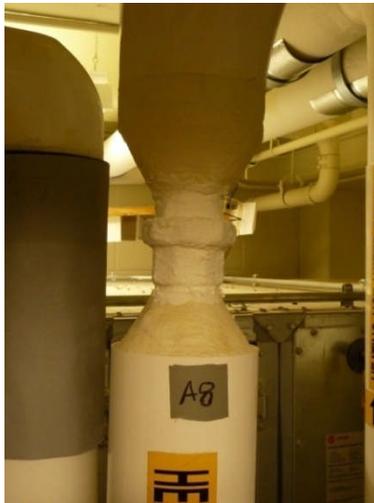
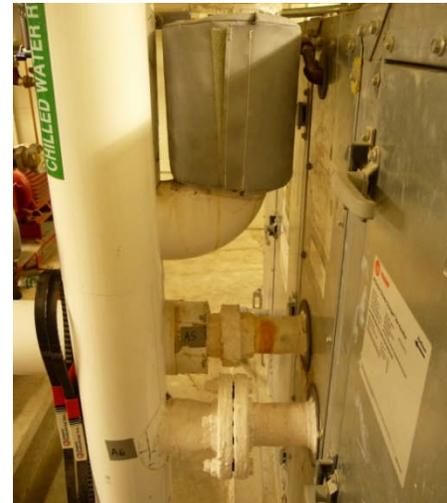
Coated Union Joints, Mechanical Room A, Twelve Months of Exposure

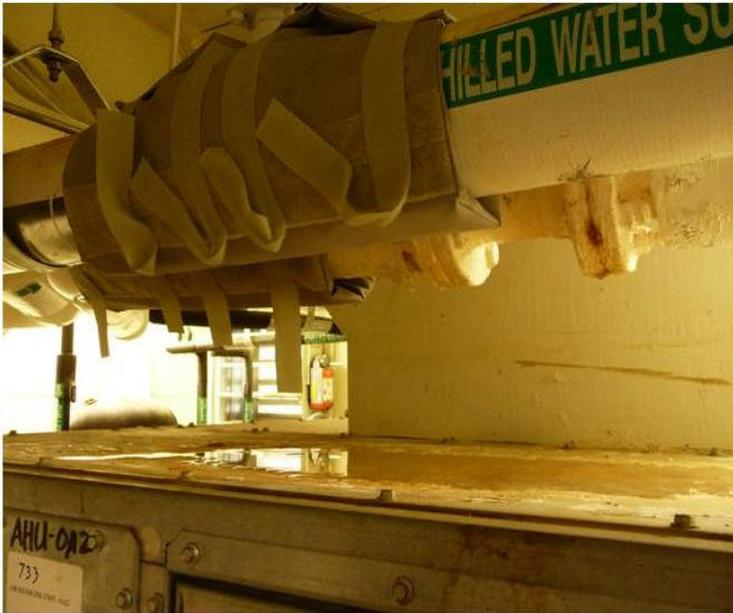
Union Joint with Removable Insulation,
Mechanical Room A, Nine Months of Exposure

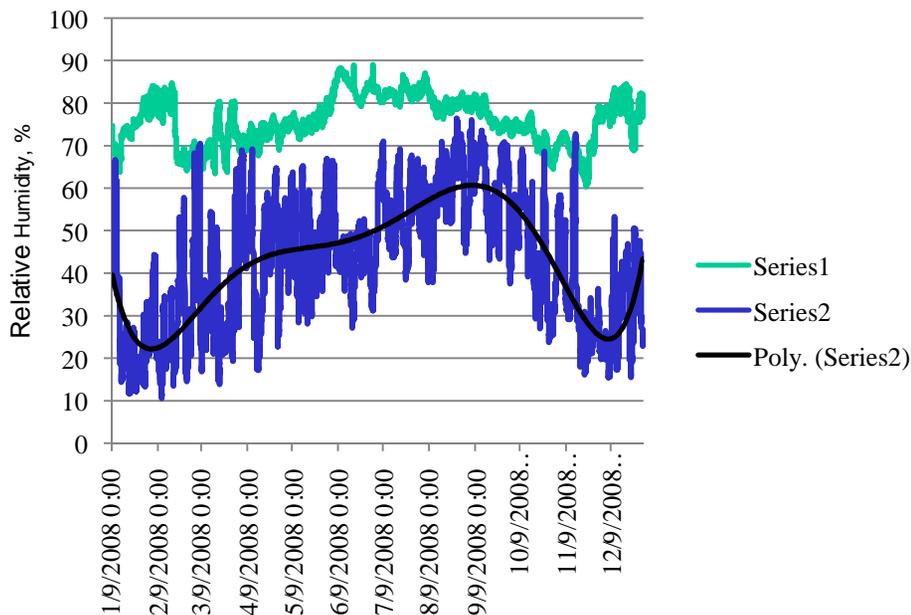
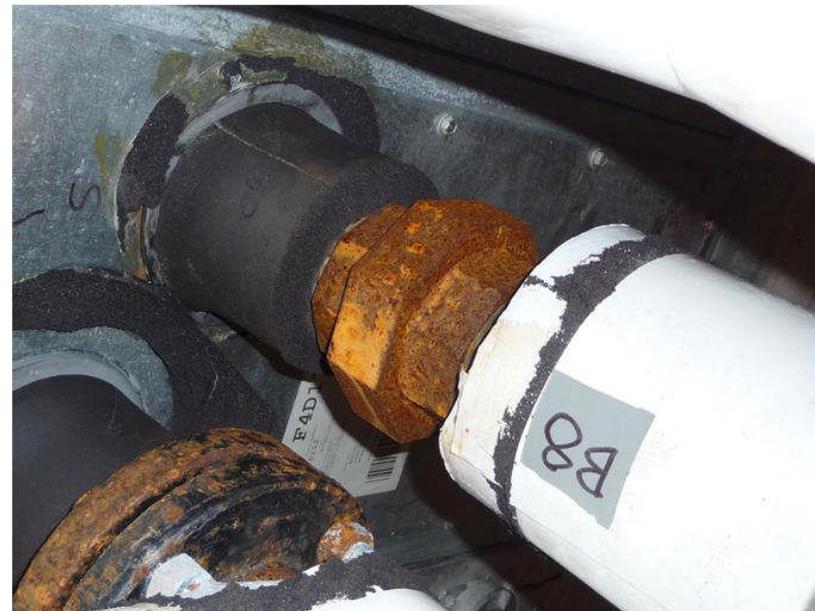
- Mechanical Rooms (cont.)
 - In general, dehumidification was not effective
 - Dehumidifier, although correctly sized for Mechanical Room B, was not able to effectively and consistently reduce humidity (and subsequently corrosion) in that room

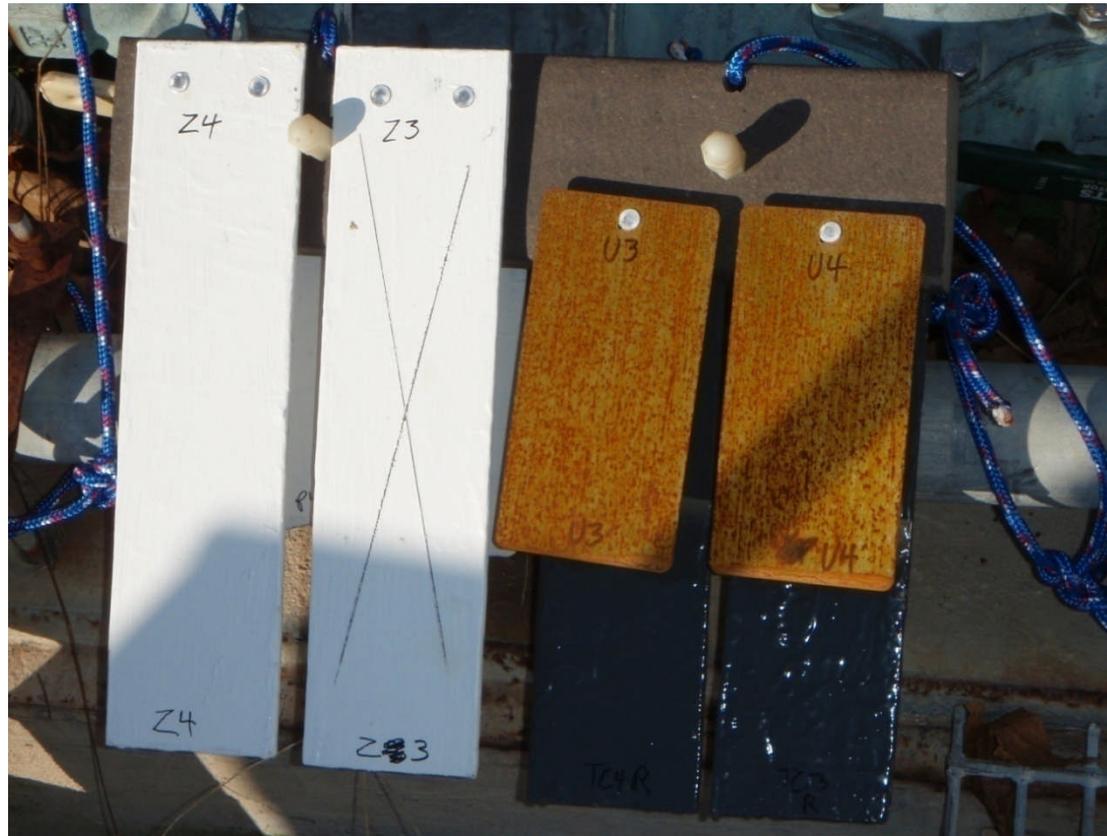
- Cooling Tower Pumps
 - Corrosion observed on uncoated panels in sumps in Feb 2009 (one-month exposure)

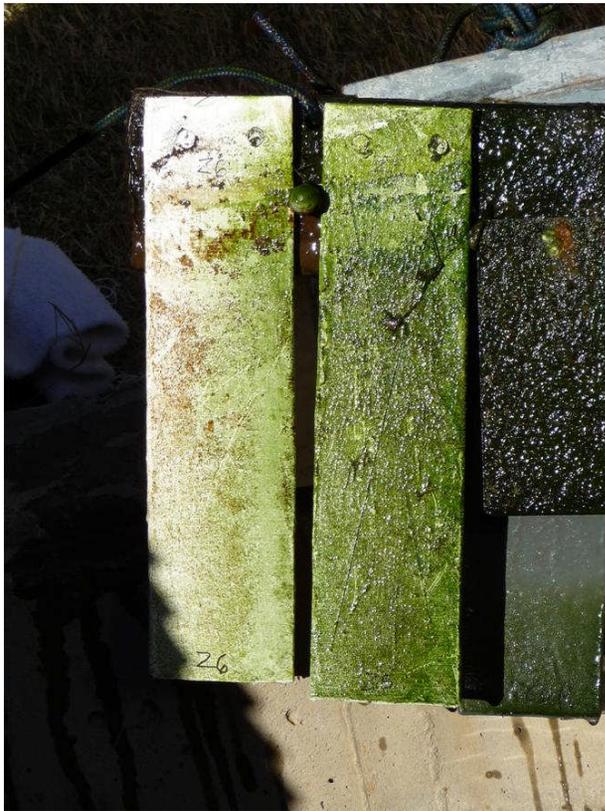
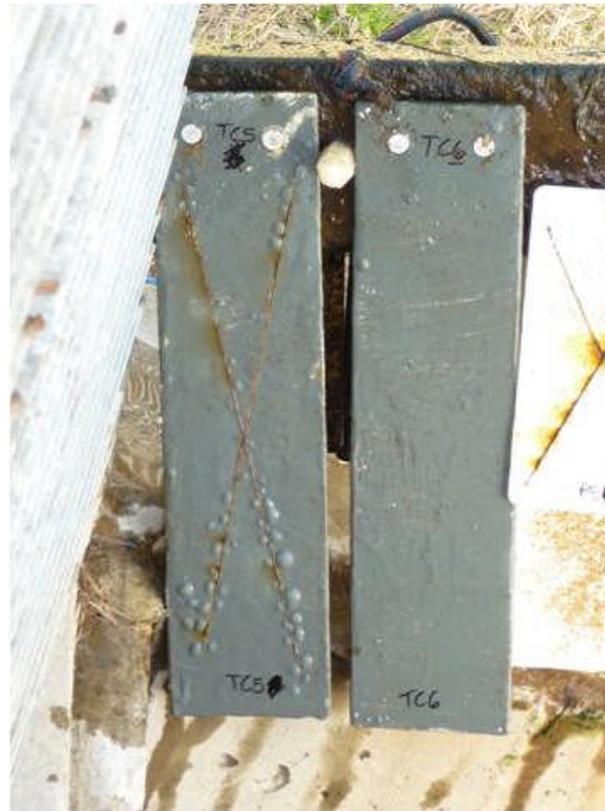
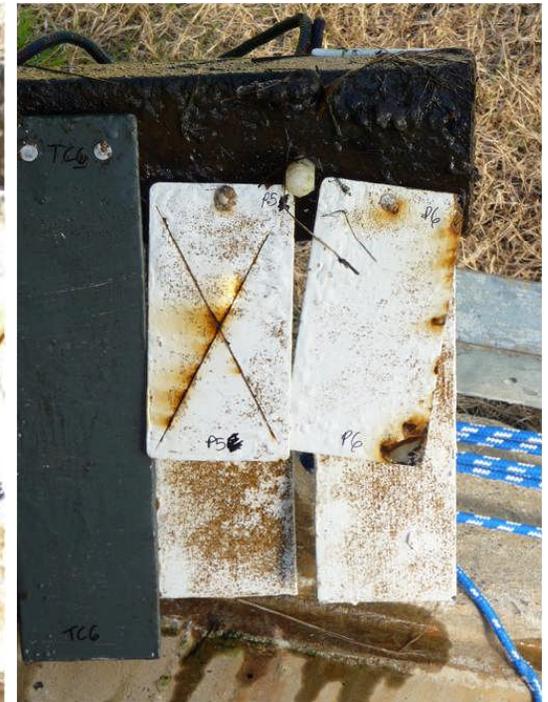
- Cooling Tower Pumps (cont.)
 - After twelve months of exposure, Paint System No. 21-A-Z outperformed commercial epoxy system
